**Sacramento Regional Transit
District**

Stockton Boulevard Implementation Plan

July 2023

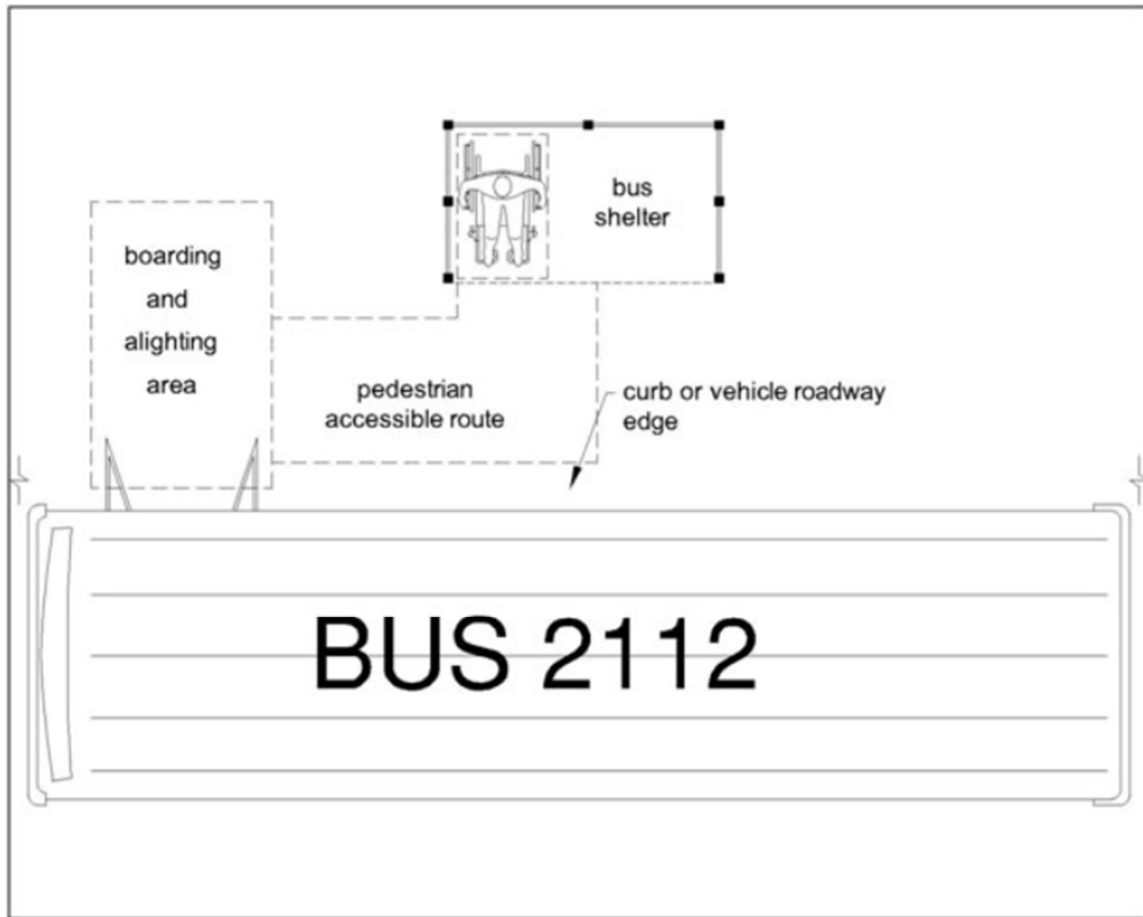
¹ 13" level height based on New Flyer Xcelsior vehicle. Actual level platform height may vary depending on the make and model of transit vehicle procured.

Source: [U.S. Access Board, PROWAG, R308.1.3.2.](#)

Boarding height is also important for accessibility and dwell-time reduction reasons. Boarding height refers to a platform's curb height in the boarding area. Providing near-level or level platforms with respect to the height of the floor of the bus reduces vertical stepping distance for people boarding and alighting transit vehicles, thereby reducing boarding and alighting times and improving accessibility for all users. Six-inch curb height is typical in the United States, with a low-floor bus floor being approximately 13" high¹, creating a seven-inch vertical distance between the top of typical curbs and floor of a low-floor bus. Minimizing this distance where possible by using eight- to ten-inch-high curb for a reduced step provides benefits in improved access and reducing dwell time.

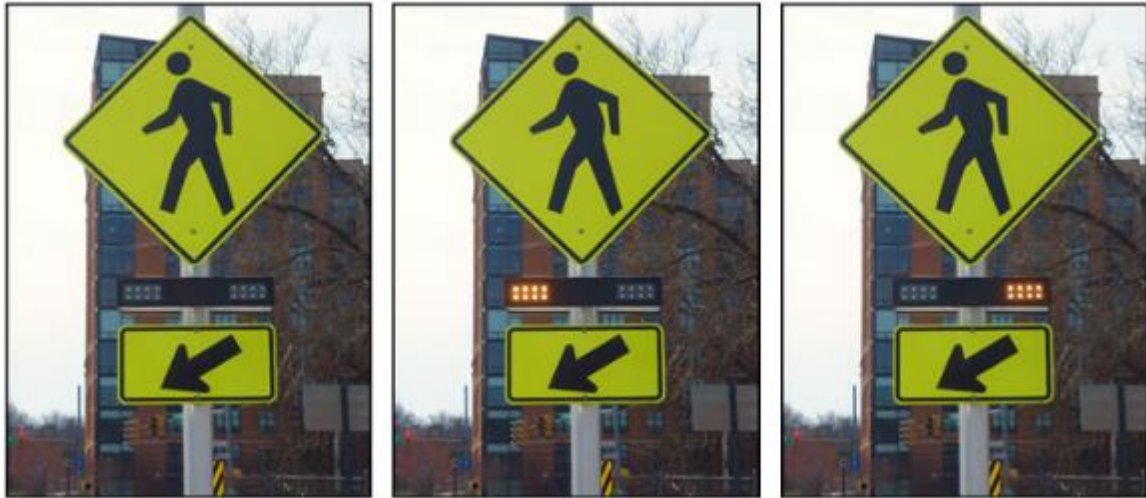
Figure 11 Rectangular Rapid Flashing Beacon

Source: [MUTCD Interim Approval for Optional Use of Pedestrian-Actuated Rectangular Rapid-Flashing Beacons](#).

The City of Sacramento Pedestrian Crossing Guidelines details conditions for installing RRFBs versus PHBs per the FHWA’s Field Guide in Figure 13 below. The Stockton Blvd Corridor Plan Existing Conditions Report (2019) identified an average ADT of greater than 15,000 vehicles per day along Stockton Blvd. As a result, Rapid Rectangular Flashing Beacons are not recommended for Stockton Blvd. As Stockton Blvd is a signalized corridor, Pedestrian Hybrid Beacons are not preferred by the City of Sacramento, and pedestrian signals are the recommended treatment to improve safety at existing unsignalized crosswalks.

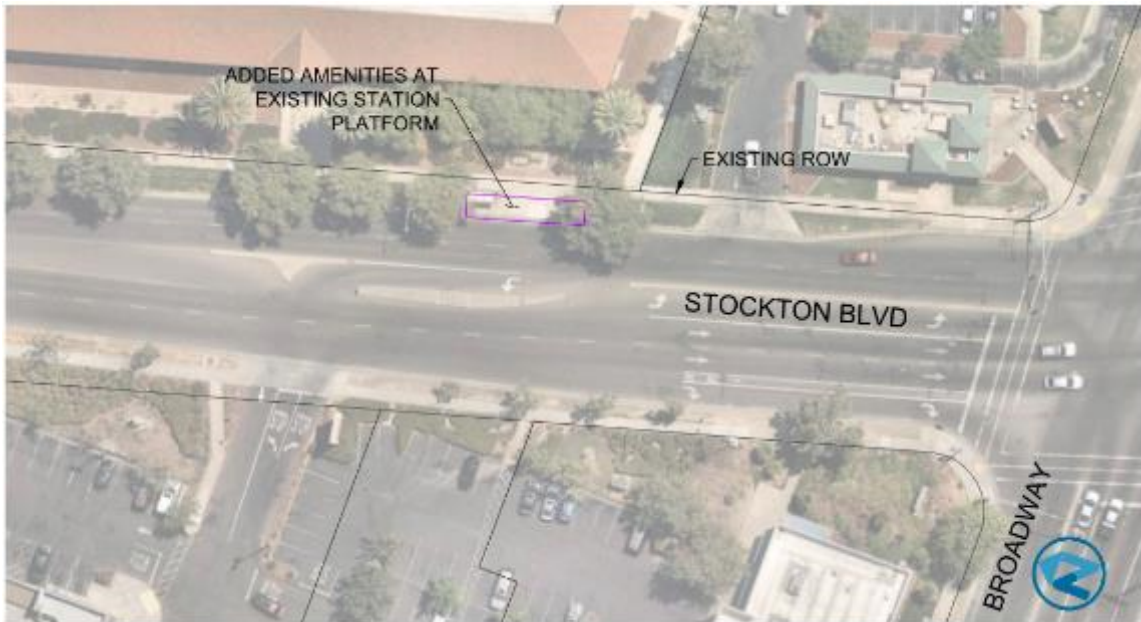
Figure 19 Stockton Blvd & Broadway NB Tier 1 Improvements

Broadway northbound (NB) and southbound (SB) (stop IDs 1807 and 1839, respectively) have high daily ridership of 68 and 132 daily riders, respectively. Both existing bus stops are on the far-side of Broadway with concrete landing areas and have a shelter with bench and trash receptacle. The NB stop has existing RTIS in place, and the SB stop has existing plans of RTIS being installed, per coordination with SacRT. Both stops are fully ADA compliant.

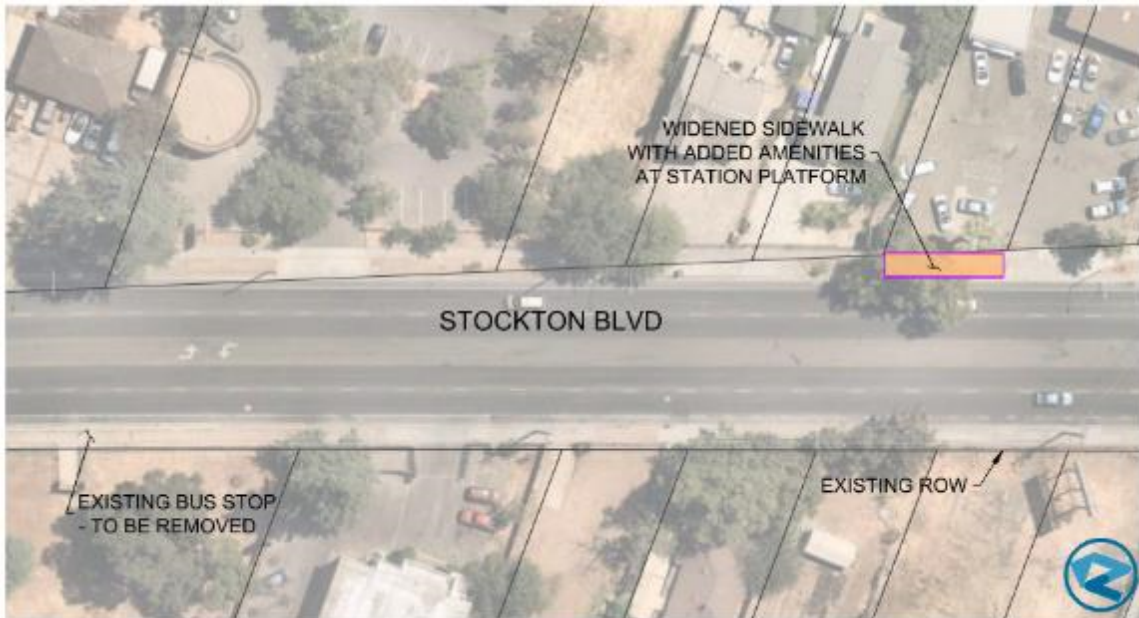
Figure 23 20th Ave NB Tier 1 Improvements

Parker Ave and Roosevelt Ave both have SB transit stops (stop IDs 1846 and 1847, respectively) with low daily ridership counts of 20 daily riders for Parker Ave and 11 daily riders for Roosevelt Ave. These two stops are located 430' apart from each other on the same block with no existing amenities at either location. The nearest SB stop to the north of Parker

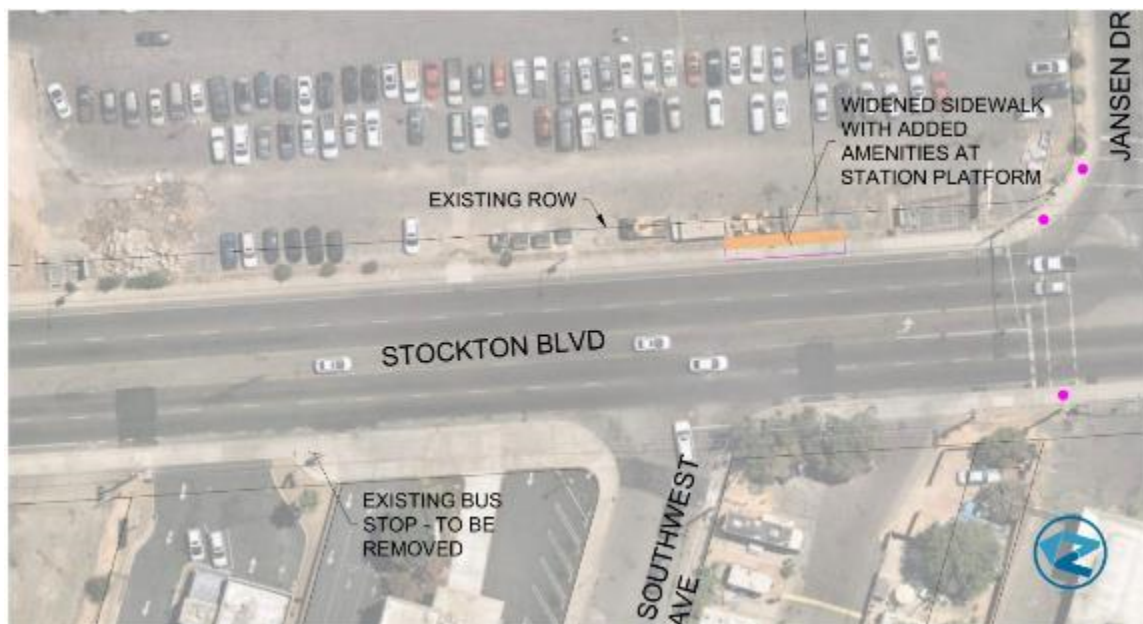
Figure 31 Southwest Ave SB/Jansen Dr NB Tier 1 Improvements

Southwest Ave and Gordon Drive currently both have SB transit stops (1852 and 1853, respectively) with relatively low daily ridership counts of 17 and 15 passengers per day, respectively. These two stops are 850' apart from each other and both are located between two driveways with minimal space for additional amenities. The Southwest Ave bus stop is located 840' from the Fruitridge Rd stop to the north and Gordon Dr bus stop is located 730' from the McMahon Drive stop to the south. Neither stop currently has a NB station pair, however there is a singular NB bus stop at the far side of Jansen Drive.

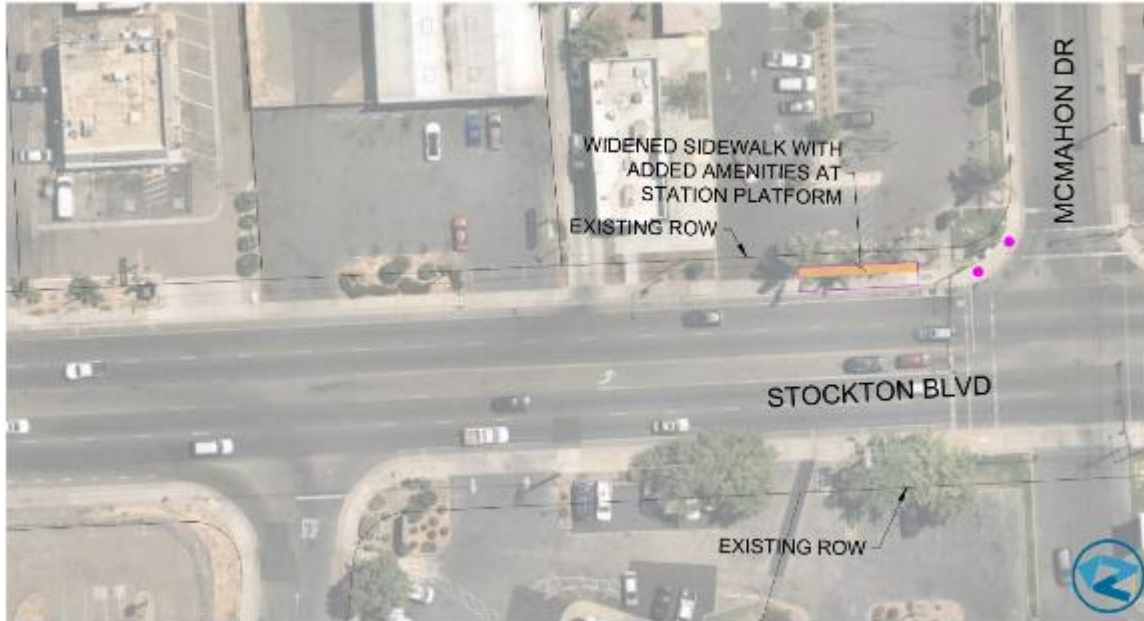
Figure 35 McMahan Dr NB Tier 1 Improvements

The McMahon Dr bus stops (NB 1890, SB 1854) are located near restaurants and shopping plazas with a relatively high daily ridership of 63 and 62 daily passengers for NB and SB, respectively. Existing amenities include a trash receptacle and a bench at the NB station and a trash receptacle at the SB station. The NB stop lacks an ADA compliant landing area and several curb ramps at the intersection require upgrades or replacement, including two on the northeast corner and one on the southeast corner.

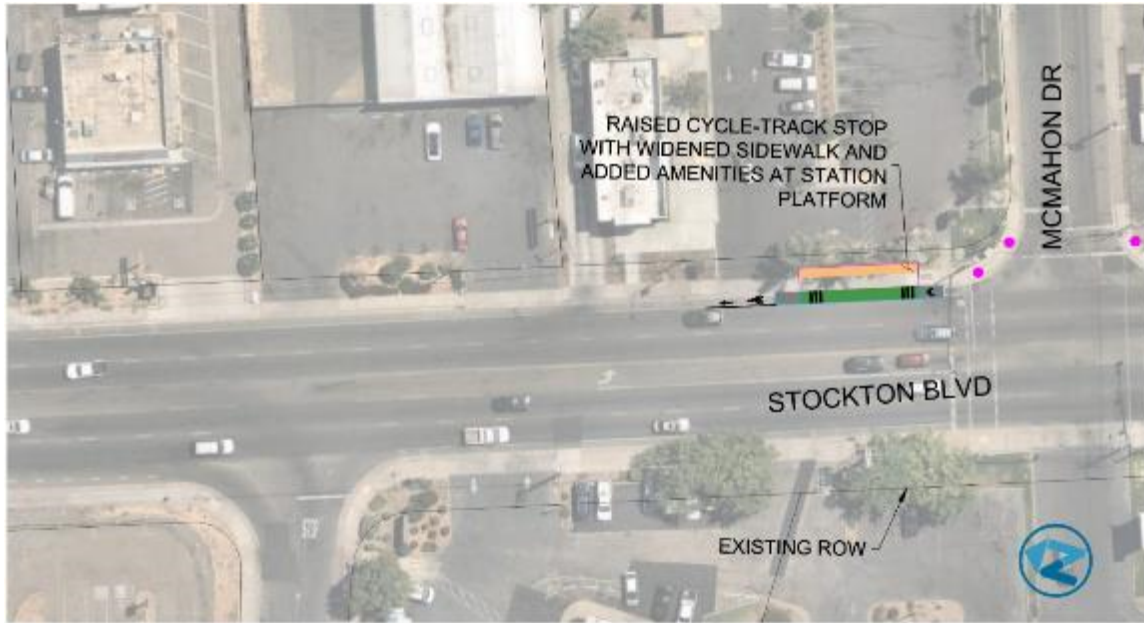
Figure 37 McMahan Dr NB Tier 2 Improvements

\$158,200 for the SB stop. The anticipated cost for the Tier 2 improvements is \$537,200; \$291,900 for the NB stop and \$245,300 for the SB stop.

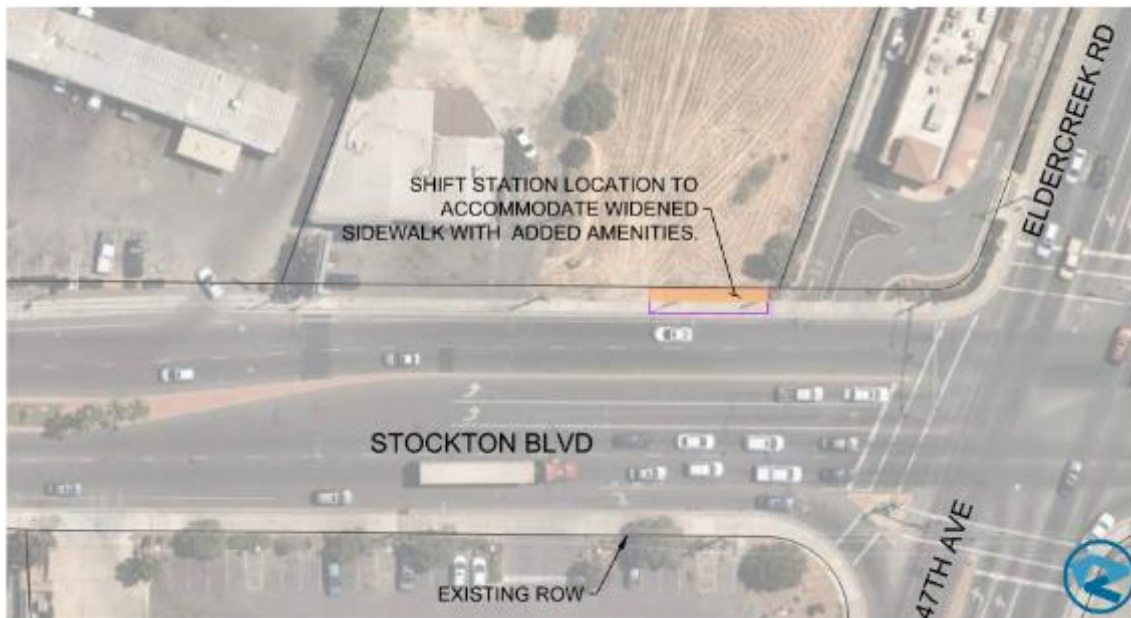
Figure 39 Elder creek Rd NB Tier 1 Improvements

Eldercreek Rd NB and 47th Ave SB (NB 1887, SB 1857) have an existing high ridership of 58 daily riders for the NB direction and 65 daily riders for the SB direction. The NB stop is a far-side near a drive-thru exit with a 5' sidewalk and no existing landing area and no amenities. The SB stop is a far-side stop at an open lot with a sign and no amenities. The landing area

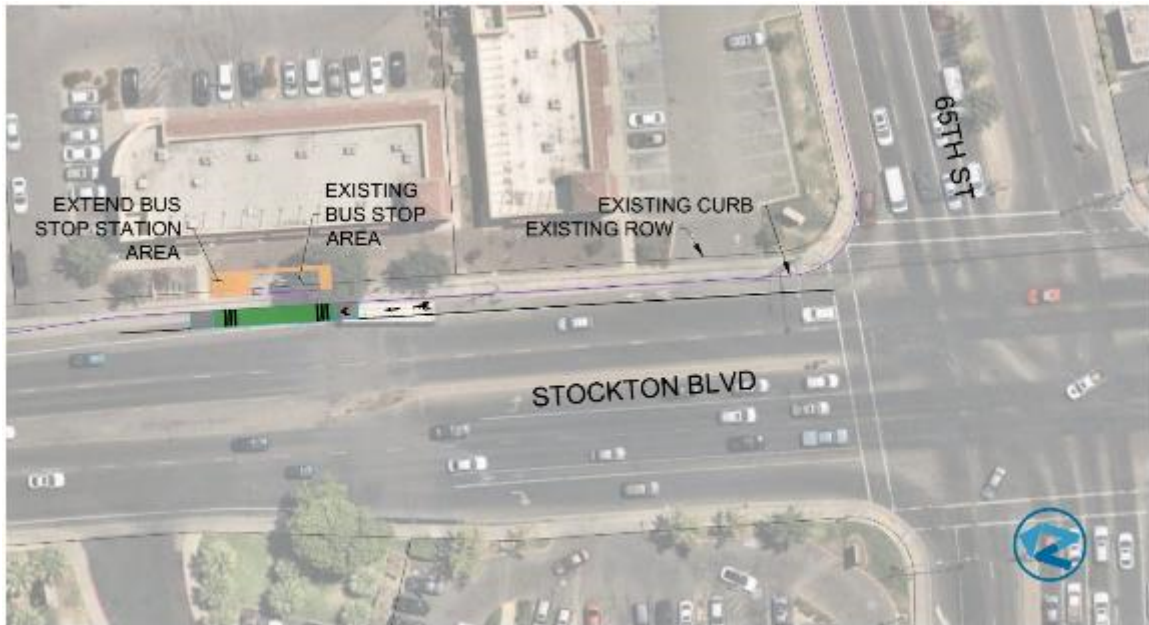
Figure 43 65th St Tier 1 NB Improvements

The 65th Street bus stops (NB 1884, SB 1860) have the highest ridership on the Stockton Blvd corridor with 252 daily riders for the NB direction and 407 daily riders for the SB direction. These stops are located in a mix of shopping plazas and have potential east-west transfer points on 65th Street. Both stops are currently located at bus pull-outs on the far-side of 65th Street with a shelter with a bench and trash receptacle at the NB stop and a bench and trash receptacle at the SB stop. The SB bus stop does not currently have an accessible landing area.

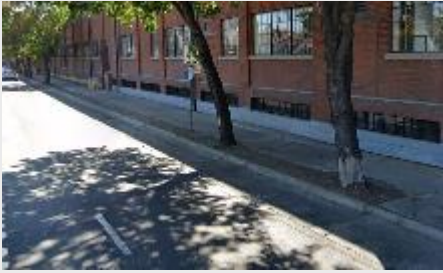
Figure A- 1 Stockton Blvd & Alhambra Blvd

Alhambra Blvd Southbound	
Stop ID	1792	
Daily Ridership	Boarding: 0 Alighting: 0	
Cost	Tier 1: \$126,825 Tier 2: N/A	
Key Considerations (ADA, ROW)	<ul style="list-style-type: none"> ▪ No Landing Area ▪ Tier 1 and Tier 2: 0' ROW Required 	
Proposed Improvements	<p>Tier 1: Widen sidewalk up to curb at bus flag for adequate landing area. Add Braille signage, bench, and route map.</p> <p>Tier 2: No additional Tier 2 improvements due to low ridership.</p>	
Image Credit: Google Maps

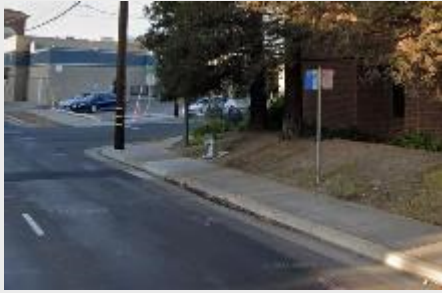
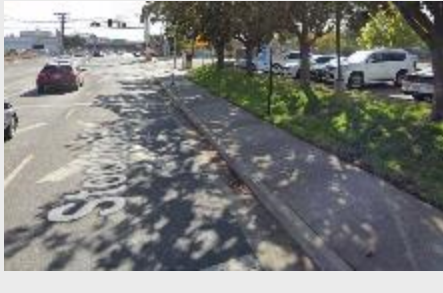
Figure A- 2 Stockton Blvd & 34th St

34 th St Eastbound	34 th St Westbound
Stop ID	1793	1824
Daily Ridership	Boarding: <1 Alighting: <1 Total: 1	Boarding: <1 Alighting: <1 Total: <1
Cost	Tier 1: \$127,000 Tier 2: N/A	Tier 1: \$127,000 Tier 2: N/A
Key Considerations (ADA, ROW)	<ul style="list-style-type: none"> No Landing Area Tier 1 and Tier 2: 0' ROW Required 	<ul style="list-style-type: none"> No Landing Area Tier 1 and Tier 2: 0' ROW Required
Proposed Improvements	<p>Tier 1: Widen station area at back of sidewalk for accessible landing area, Braille signage, route map, and bench.</p> <p>Tier 2: No additional Tier 2 improvements due to low ridership.</p>	<p>Tier 1: Widen station area at back of sidewalk for accessible landing area, Braille signage, route map, and bench.</p> <p>Tier 2: No additional Tier 2 improvements due to low ridership.</p>
Image Credit: Google Maps

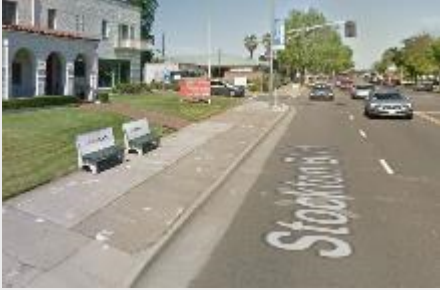
Figure A- 3 Stockton Blvd & Miller Way SB

Miller Way Southbound	
Stop ID	3717	
Daily Ridership	Boarding: 2 Alighting: 3 Total: 5	
Cost	Tier 1: \$300 Tier 2: \$300	
Key Considerations (ADA, ROW)	<ul style="list-style-type: none"> ▪ Landing Area and Curb Ramp Accessible ▪ Low ridership and no station pair ▪ Tier 1 and Tier 2: 0' ROW Required 	
Proposed Improvements	<p>Tier 1: Add Braille signage, and system and route maps.</p> <p>Tier 2: Add striped crosswalk on south leg of intersection, Braille signage, and system and route maps.</p>	
Image Credit: Google Maps

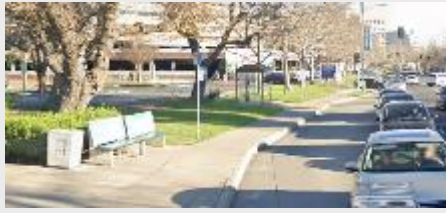
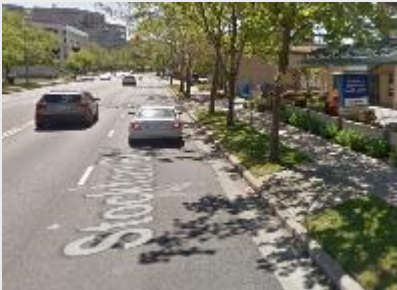
Figure A- 4 Stockton Blvd & Colonial Way

Colonial Way Northbound	Colonial Way Southbound
Stop ID	1811	3718
Daily Ridership	Boarding: 5 Alighting: 2 Total: 7	Boarding: 1 Alighting: 3 Total: 4
Cost	Tier 1: \$155,800 Tier 2: \$470,000	Tier 1: \$164,300 Tier 2: \$164,300
Key Considerations (ADA, ROW)	<ul style="list-style-type: none"> ▪ Landing Area and Curb Ramp Accessible ▪ Tier 1: 5' ROW Required ▪ Tier 2: 0' ROW Required 	<ul style="list-style-type: none"> ▪ Landing Area and Curb Ramp Accessible ▪ Tier 1 and Tier 2: 0' ROW Required
Proposed Improvements	<p>Tier 1: Widen station platform to the south at the back of sidewalk accommodate shelter with bench, Braille signage, and route map.</p> <p>Tier 2: Fill in pullout to create in-lane stop. Create station platform with shelter with bench, Braille signage, and route map. Add pedestrian crossing on north leg of intersection and 2 new curb ramps.</p>	<p>Tier 1: Extend station platform between curb and sidewalk to the south to accommodate shelter with bench, Braille signage, and route map.</p> <p>Tier 2: Maintain Tier 1 improvements. Shift stop bar on west leg of intersection back and add crosswalk striping</p>

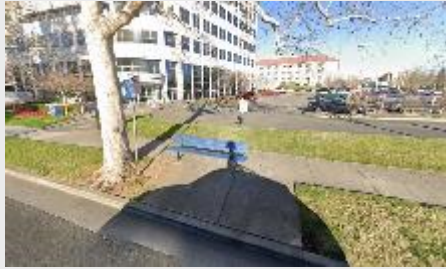
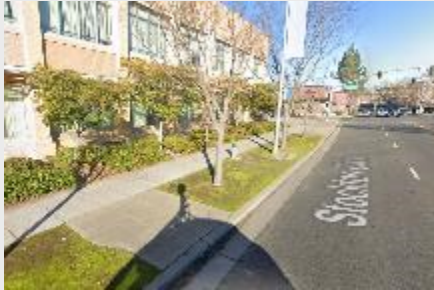
Figure A- 6 Stockton Blvd & 2nd Ave

2 nd Ave Northbound	2 nd Ave Southbound
Stop ID	1809	3720
Daily Ridership	Boarding: 8 Alighting: 2 Total: 10	Boarding: 3 Alighting: 2 Total: 5
Cost	Tier 1: \$2,300 Tier 2: N/A	Tier 1: \$300 Tier 2: N/A
Key Considerations (ADA, ROW)	<ul style="list-style-type: none"> ▪ Existing landing area potentially blocked by bench. ▪ Cost assumed for maintenance crew to remove amenities. ▪ Tier 1 and Tier 2: 0' ROW Required 	<ul style="list-style-type: none"> ▪ No Landing Area ▪ Tier 1 and Tier 2: 0' ROW Required
Proposed Improvements	<p>Tier 1: Propose remove stop. Remove bench and flag.</p> <p>Tier 2: No additional improvements due to removed stop.</p>	<p>Tier 1: Propose remove stop.</p> <p>Tier 2: No additional improvements due to removed stop.</p>
Image Credit: Google Maps

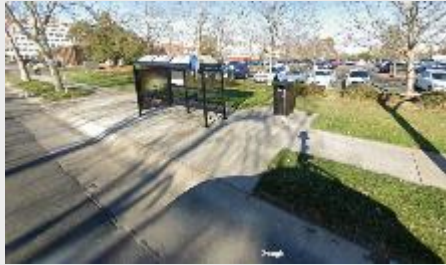
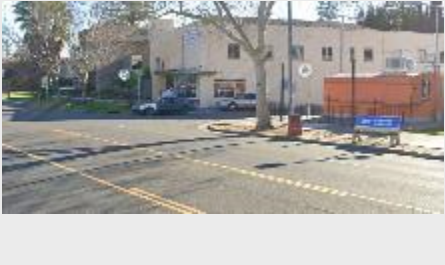
Figure A- 7 Stockton Blvd & 3rd Ave

3 rd Ave Northbound	3 rd Ave Southbound
Stop ID	1808	3721
Daily Ridership	Boarding: 3 Alighting: 2 Total: 5	Boarding: 2 Alighting: 3 Total: 5
Cost	Tier 1: \$4,800 Tier 2: \$1,115,700	Tier 1: \$166,000 Tier 2: \$181,000
Key Considerations (ADA, ROW)	<ul style="list-style-type: none"> ▪ Landing Area and Curb Ramp Accessible ▪ Tier 1 and Tier 2: 0' ROW Required 	<ul style="list-style-type: none"> ▪ No landing area ▪ Tier 1 and Tier 2: 0' ROW Required
Proposed Improvements	<p>Tier 1: Relocate shelter to back of sidewalk and add Braille signage.</p> <p>Tier 2: Relocate stop and amenities closer to far-side 3rd Ave. Add Braille signage, pedestrian crossing with a pedestrian signal, 3 new curb ramps.</p>	<p>Tier 1: Create a formal station area by widening sidewalk up to curb to accommodate accessible landing area, shelter with bench, Braille signage and route map.</p> <p>Tier 2: Maintain Tier 1 improvements. Upgrade curb ramp on the south corner of 3rd and Stockton Blvd.</p>

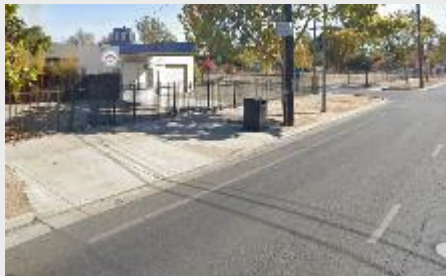
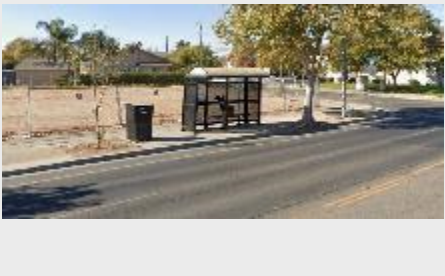
9 th Ave Northbound	9 th Ave Southbound
Stop ID	1902	1841
Daily Ridership	Boarding: 13 Alighting: 10 Total: 23	Boarding: 19 Alighting: 14 Total: 33
Cost	Tier 1: \$223,800 Tier 2: \$458,000	Tier 1: \$300 Tier 2: \$200,200
Key Considerations (ADA, ROW)	<ul style="list-style-type: none"> ▪ Landing Area and Curb Ramp Accessible ▪ Tier 1 and Tier 2: 6' ROW Required 	<ul style="list-style-type: none"> ▪ Landing Area and Curb Ramp Accessible ▪ Tier 1 and Tier 2: 0' ROW Required
Proposed Improvements	<p>Tier 1: Extend station platform to the south to accommodate shelter with bench, Braille signage, and route map. Station area can be improved while maintaining existing tree.</p> <p>Tier 2: Relocate stop to far-side of existing pedestrian signal. Create shared cycle track stop and widen sidewalk to accommodate a formal station area. Maintain all proposed Tier 1 amenities and add a pedestrian refuge at the existing pedestrian crossing.</p>	<p>Tier 1: Add Braille signage.</p> <p>Tier 2: Relocate stop to far- side of existing pedestrian signal. Create shared cycle track stop and widen sidewalk for formal station area. Relocate shelter with bench and trash receptacle. Add Braille signage.</p>

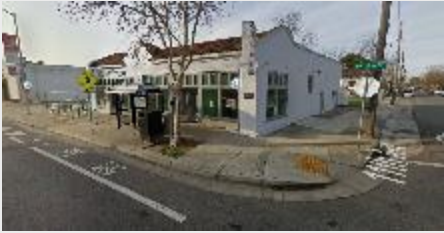
Figure A- 10 Stockton Blvd & 11th Ave

11 th Ave Northbound	11 th Ave Southbound
Stop ID	1901	1842
Daily Ridership	Boarding: 11 Alighting: 5 Total: 16	Boarding: 6 Alighting: 8 Total: 14
Cost	Tier 1: \$234,300 Tier 2: \$1,188,300	Tier 1: \$300 Tier 2: \$226,400
Key Considerations (ADA, ROW)	<ul style="list-style-type: none"> No landing area Tier 1 and 2: 1' ROW Required 	<ul style="list-style-type: none"> Landing Area and Curb Ramp Accessible Tier 1: 0' ROW Required Tier 2: 6' ROW Required
Proposed Improvements	<p>Tier 1: Create a formal station area by widening sidewalk up to curb to accommodate accessible landing area, shelter with bench, Braille signage, and route map.</p> <p>Tier 2: Maintain Tier 1 improvements. Upgrade crossing with pedestrian refuge and a pedestrian signal.</p>	<p>Tier 1: Add Braille signage.</p> <p>Tier 2: Relocate station and amenities to far-side of crosswalk. Close driveway for additional space. Add Braille signage and upgrade crossing with pedestrian refuge and a pedestrian signal.</p>

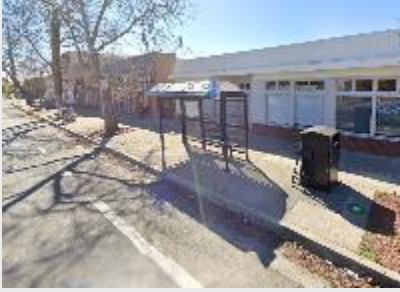
Figure A- 11 Stockton Blvd & 14th Ave

14 th Ave Northbound	14 th Ave Southbound
Stop ID	1899	1843
Daily Ridership	Boarding: 26 Alighting: 11 Total: 37	Boarding: 8 Alighting: 16 Total: 24
Cost	Tier 1: \$300 Tier 2: \$206,000	Tier 1: \$300 Tier 2: \$87,500
Key Considerations (ADA, ROW)	<ul style="list-style-type: none"> ▪ Landing Area and Curb Ramp Accessible ▪ Tier 1 and Tier 2: 0' ROW Required 	<ul style="list-style-type: none"> ▪ Landing Area and Curb Ramp Accessible ▪ Tier 1: 0' ROW Required ▪ Tier 2: 8' ROW Required
Proposed Improvements	<p>Tier 1: Add Braille signage.</p> <p>Tier 2: Close driveway closest to intersection to provide pedestrian crossing on north leg of intersection and add Braille signage.</p>	<p>Tier 1: Add Braille signage.</p> <p>Tier 2: Relocate stop to far-side 14th Ave. Relocate existing shelter and trash receptacle to new location. Add Braille signage.</p>
Image Credit: Google Maps

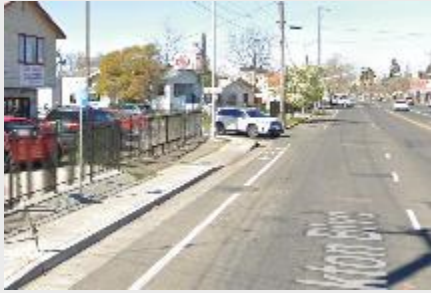
Figure A- 12 Stockton Blvd & 15th Ave

15 th Ave Southbound
Stop ID		1844
Daily Ridership		Boarding: 5 Alighting: 11 Total: 16
Cost		Tier 1: \$300 Tier 2: \$0
Key Considerations (ADA, ROW)		<ul style="list-style-type: none"> ▪ No landing area ▪ Tier 1 and Tier 2: 0' ROW Required
Proposed Improvements		<p>Tier 1: Remove bus stop.</p> <p>Tier 2: Consolidate 14th Ave SB and 15th Ave SB stops by relocating these stops to one stop on far-side of 14th Ave.</p>
Image Credit: Google Maps

- 15th Ave SB (stop ID 1844) is an existing far-side bus stop with no amenities, no station pair, and no accessible landing area. This bus stop is location 575' south of the 14th Ave bus stop and 640' north of the 17th Ave bus stop. Due to the low daily ridership of this bus stop at 14 people per day, and the proximity to both the 14th Ave and 17th Ave bus stops, it is recommended that this bus stop be removed and consolidated with the 14th Ave bus stop.

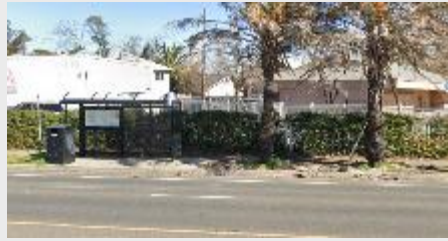
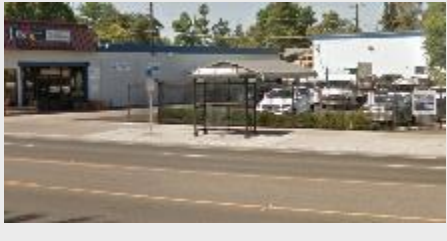
Figure A- 13 Stockton Blvd & San Francisco Blvd NB/17th Ave SB

San Francisco Blvd Northbound	17 th Ave Southbound
Stop ID	1898	1845
Daily Ridership	Boarding: 30 Alighting: 11 Total: 41	Boarding: 10 Alighting: 21 Total: 31
Cost	Tier 1: \$300 Tier 2: \$1,424,700	Tier 1: \$300 Tier 2: \$171,500
Key Considerations (ADA, ROW)	<ul style="list-style-type: none"> ▪ Landing Area and Curb Ramp Accessible ▪ Tier 1 and Tier 2: 0' ROW Required 	<ul style="list-style-type: none"> ▪ Landing Area and Curb Ramp Accessible ▪ Tier 1: 0' ROW Required ▪ Tier 2: 13' ROW Required
Proposed Improvements	<p>Tier 1: Add Braille signage.</p> <p>Tier 2: Remove midblock signal and add full signal with pedestrian crossings at 17th Ave and Stockton Blvd intersection. Add Braille signage.</p>	<p>Tier 1: Add Braille signage, system and route map.</p> <p>Tier 2: Add Braille signage, system and route map. Remove midblock signal and add full signal with pedestrian crossings at 17th Ave and Stockton Blvd intersection.</p>

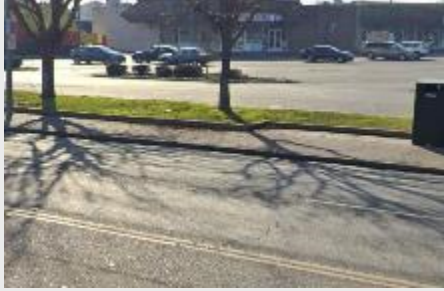
Figure A- 14 Stockton Blvd & Parker Ave SB

Northbound	Parker Ave Southbound
Stop ID		1846
Daily Ridership		Boarding: 11 Alighting: 10 Total: 21
Cost		Tier 1: \$300 Tier 2: \$300
Key Considerations (ADA, ROW)		<ul style="list-style-type: none"> ▪ No landing area ▪ Tier 1 and Tier 2: 0' ROW Required
Proposed Improvements		<p>Tier 1: Remove bus stop.</p> <p>Tier 2: Remove bus stop.</p>
Image Credit: Google Maps

To allow for better stop access and more reliable service, it is recommended to consolidate the Parker Ave and Roosevelt Ave bus stops into one bus stop at the far side of Roosevelt Ave. The resulting SB stop is spaced 1370' south of the 17th Ave stop and 800' north of the 21st Ave stop. Additional Tier 1 improvements for the new Roosevelt Ave SB Stop and station pair at 20th Ave NB locations include widening the sidewalk to accommodate an accessible landing area, a shelter with a bench, Braille signage, and system and route maps.

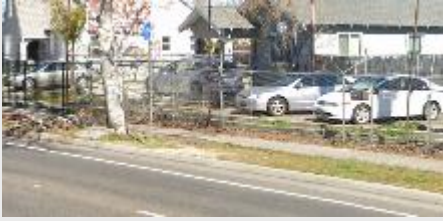
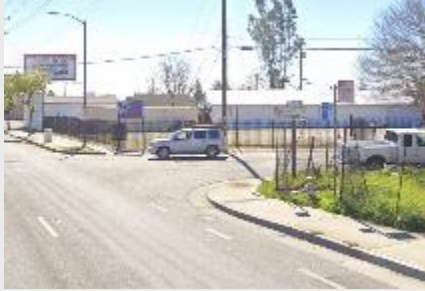
Figure A- 15 Stockton Blvd & 20th Ave NB/ Roosevelt Ave SB

20 th Ave Northbound	Roosevelt Ave Southbound
Stop ID	1896	1847
Daily Ridership	Boarding: 10 Alighting: 11 Total: 21	Boarding: 4 Alighting: 7 Total: 11
Cost	Tier 1: \$208,800 Tier 2: \$1,179,800	Tier 1: \$99,500 Tier 2: \$209,200
Key Considerations (ADA, ROW)	<ul style="list-style-type: none"> No landing area Tier 1 and Tier 2: 0' ROW Required 	<ul style="list-style-type: none"> No landing area Tier 1 and Tier 2: 10' ROW required
Proposed Improvements	<p>Tier 1: Create a formal station area by widening sidewalk up to curb to accommodate accessible landing area, shelter with bench, Braille signage, and route map.</p> <p>Tier 2: Maintain Tier 1 improvements. Create cycle track stop, midblock crossing, including pedestrian refuge and a pedestrian signal.</p>	<p>Tier 1: Relocate stop to far-side of Roosevelt Ave. Add shelter with bench, Braille signage, and route map.</p> <p>Tier 2: Tier 1 with cycle track stop, midblock crossing, including two new curb ramps, pedestrian refuge, and a pedestrian signal.</p>

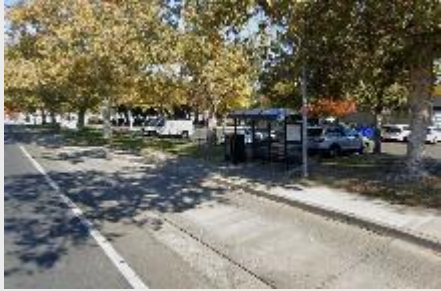
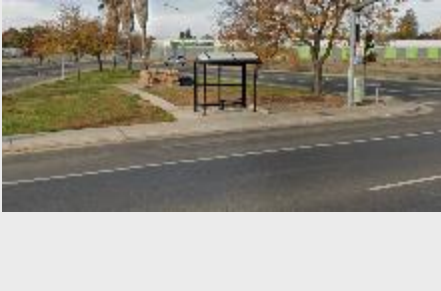
Figure A- 16 Stockton Blvd & 21st Ave

21 st Ave Northbound	21 st Ave Southbound
Stop ID	1895	1848
Daily Ridership	Boarding: 34 Alighting: 18 Total: 54	Boarding: 15 Alighting: 27 Total: 42
Cost	Tier 1: \$100,200 Tier 2: \$389,900	Tier 1: \$300 Tier 2: \$224,700
Key Considerations (ADA, ROW)	<ul style="list-style-type: none"> ▪ Landing Area and Curb Ramp Accessible ▪ Tier 1: 13.5' ROW Required ▪ Tier 2: 6' ROW Required 	<ul style="list-style-type: none"> ▪ Landing Area and Curb Ramp Accessible ▪ Tier 1 and Tier 2: 0' ROW Required
Proposed Improvements	<p>Tier 1: Add RTIS, Braille signage, and pedestrian scale lighting.</p> <p>Tier 2: Create transit island, routing bike lane behind bus stop. Relocate existing amenities and add pedestrian scale lighting.</p>	<p>Tier 1: Add Braille signage, system and route maps.</p> <p>Tier 2: Create dedicated bike lane with shared cycle track stop. Add Braille signage, system and route maps.</p>
Image Credit: Google Maps

- 21st Ave NB and SB (stop IDs 1895 and 1848, respectively) are both far-side stops with shelter and benches and are fully ADA compliant. The daily ridership for the NB bus stop is 52 passengers, and the daily ridership for the SB bus stop is 42 passengers. Improvements to bring this station pair up to the standards identified in this report are to add RTIS, Braille signage, and pedestrian scale lighting at both locations, and add system and route maps that are currently missing from the SB bus stop. While the SB bus stop is under the threshold for RTIS and pedestrian scale lighting, these amenities are recommended with the anticipation that improving the bus stop will create a better station environment and bring additional passengers.

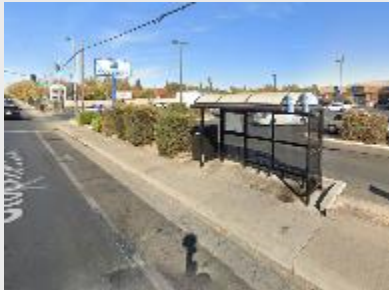
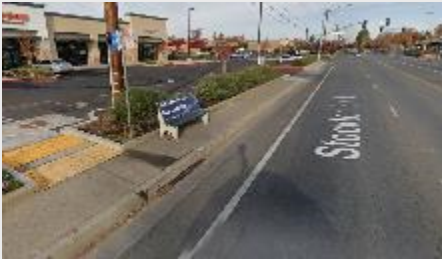
Figure A- 17 Stockton Blvd & Lawrence Dr

Lawrence Dr Northbound	Lawrence Dr Southbound
Stop ID	1894	1849
Daily Ridership	Boarding: 38 Alighting: 12 Total: 50	Boarding: 13 Alighting: 30 Total: 43
Cost	Tier 1: \$143,800 Tier 2: \$232,400	Tier 1: \$158,600 Tier 2: \$228,500
Key Considerations (ADA, ROW)	<ul style="list-style-type: none"> No Landing Area Tier 1: 0' ROW Required Tier 2: 3' ROW Required 	<ul style="list-style-type: none"> No Landing Area Tier 1 and Tier 2: 0' ROW Required
Proposed Improvements	<p>Tier 1: Add RTIS, pedestrian scale lighting and Braille signage.</p> <p>Tier 2: Create shared cycle track and widen sidewalk into existing landscaping and parking lot to accommodate more pedestrian waiting space, RTIS, pedestrian scale lighting, and Braille signage.</p>	<p>Tier 1: Widen sidewalk into the existing landscaping to accommodate station platform with accessible landing area, shelter with bench, pedestrian scale lighting, trash receptacle, and Braille signage.</p> <p>Tier 2: Create shared cycle track stop and widen station area along back the of sidewalk to accommodate accessible landing area, shelter with bench, pedestrian scale lighting, trash receptacle, and Braille signage.</p>

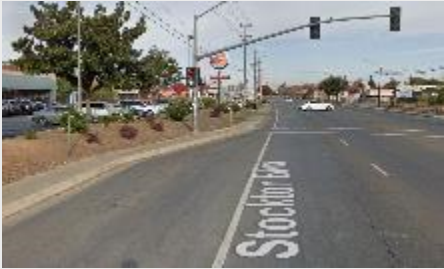
Figure A- 18 Stockton Blvd and Fruitridge Rd (Plaza)

Fruitridge Rd (Plaza) Northbound	Fruitridge Rd (Plaza) Southbound
Stop ID	1893	1850
Daily Ridership	Boarding: 50 Alighting: 14 Total: 64	Boarding: 25 Alighting: 78 Total: 103
Cost	Tier 1: \$170,600 Tier 2: \$272,700	Tier 1: \$164,700 Tier 2: \$798,000
Key Considerations (ADA, ROW)	<ul style="list-style-type: none"> No Landing Area Tier 1 and Tier 2: 0' ROW Required 	<ul style="list-style-type: none"> No Landing Area Tier 1 and Tier 2: 4' ROW Required
Proposed Improvements	<p>Tier 1: Extend station platform along back of sidewalk to accommodate shelter with bench, RTIS, trash receptacle, system and route maps, Braille signage, and pedestrian scale lighting.</p> <p>Tier 2: Maintain Tier 1 improvements. Create a shared cycle track stop.</p>	<p>Tier 1: Extend station platform along back of sidewalk to accommodate shelter with bench, RTIS, trash receptacle system and route maps, Braille signage, and pedestrian scale lighting.</p> <p>Tier 2: Create a transit island routing bike lane behind bus stop. Add shelter with bench, RTIS, trash receptacle system and route maps, Braille signage, and pedestrian scale lighting. Straighten midblock crossing, add a pedestrian refuge and two new curb ramps.</p>

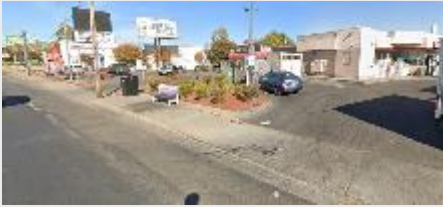
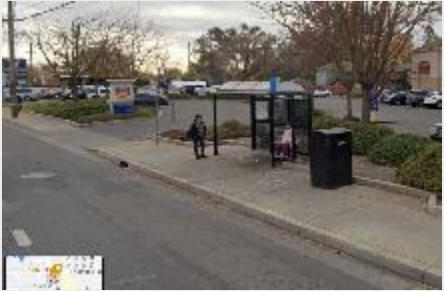
Figure A- 19 Stockton Blvd & Fruitridge Rd

Fruitridge Rd Northbound	Fruitridge Rd Southbound
Stop ID	1892	1851
Daily Ridership	Boarding: 76 Alighting: 42 Total: 118	Boarding: 53 Alighting: 49 Total: 102
Cost	Tier 1: \$199,100 Tier 2: \$397,400	Tier 1: \$216,700 Tier 2: \$216,700
Key Considerations (ADA, ROW)	<ul style="list-style-type: none"> ▪ Landing Area Accessible ▪ Curb ramps require minor upgrades ▪ Tier 1: 7' ROW Required ▪ Tier 2: 3' ROW Required 	<ul style="list-style-type: none"> ▪ Landing Area accessible ▪ Curb ramps require minor upgrades ▪ Tier 1 and Tier 2: 4' ROW Required
Proposed Improvements	<p>Tier 1: Use existing landscaping space for additional amenities without affecting existing driveways. Add shelter with bench, RTIS, System and route map, Braille signage, and pedestrian scale lighting. Will require additional ROW. Widen station area along the back of the sidewalk at north end of bus stop to minimum 4' width around utility pole. Upgrade 2 curb ramps on NE corner of intersection</p> <p>Tier 2: Close driveway north of bus stop. Create shared cycle track stop. Widen station area along the back of the sidewalk towards the north to create a minimum 4' width around utility pole. Add shelter with bench, RTIS, System and route map, Braille signage, and pedestrian scale lighting. Upgrade 2 curb ramps on NE corner of intersection.</p>	<p>Tier 1: Add bench, RTIS, Braille signage, and pedestrian scale lighting. Widen station area along the back of the sidewalk towards the south to accommodate a 4' path around existing utility pole. Upgrade 4 curb ramps on NW and SW corner of intersection.</p> <p>Tier 2: Maintain Tier 1 improvements. Due to existing bus pullout being space for operational/layover space, no additional Tier 2 improvements are proposed.</p>

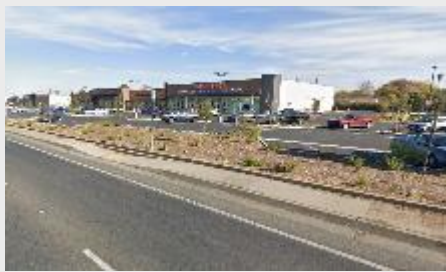
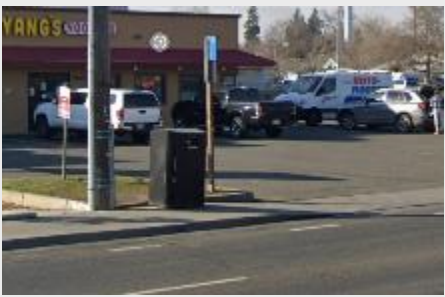
Jansen Dr NB	Gordon Dr SB
Stop ID	1891	1853
Daily Ridership	Boarding: 17 Alighting: 12 Total: 29	Boarding: 3 Alighting: 12 Total: 15
Cost	Tier 1: \$197,600 Tier 2: \$341,000	Tier 1: \$237,700 Tier 2: \$307,400
Key Considerations (ADA, ROW)	<ul style="list-style-type: none"> No ADA Landing Area Tier 1 and Tier 2: 0' ROW Required 	<ul style="list-style-type: none"> Landing Area and Curb Ramp Accessible Tier 1 and Tier 2: 0' ROW Required
Proposed Improvements	<p>Tier 1: Extend sidewalk into existing landscaping to accommodate shelter with bench, Braille signage, system and route maps. Remove existing curb ramp in middle of sidewalk since it does not lead to a safe crossing and to create a level boarding and alighting area. Upgrade two curb ramps at NE Corner of Jansen Dr.</p> <p>Tier 2: Create shared cycle track stop with station platform behind sidewalk to accommodate shelter with bench, Braille signage, system and route maps. Upgrade two curb ramps at NE Corner of Jansen Dr.</p>	<p>Tier 1: Relocate stop to far-side of Jansen Dr. Close driveway of current empty lot to provide space for station footprint. Assuming consolidated stop will bring higher ridership, add shelter with bench, Braille signage, system and route maps. Upgrade existing curb ramp on north leg of Jansen Dr. intersection.</p> <p>Tier 2: Relocate stop to far-side of Jansen Dr. Close driveway of current empty lot to provide space for station footprint. Assuming consolidated stop will bring higher ridership, add shelter with bench, Braille signage, system and route maps. Upgrade existing curb ramp on north leg of Jansen Dr. intersection. Create shared in-lane stop at new location. Add crossing on south leg of Jansen Dr intersection with 2 new curb ramps and 4 upgraded curb ramps.</p>

To provide a bus stop with a more comfortable waiting area, improved accessibility, and proximity to a signalized crossing, it is recommended to consolidate the Southwest Ave and Gordon Dr stops to one bus stop on the far side of Jansen Drive, resulting in SB stop spacing of 1,400' to the Fruitridge stop to the north and 980' to the McMahon Drive stop to the south. Additional Tier 1 improvements include adding a shelter with bench, Braille signage and upgrading the existing curb ramp on the NW corner of the Jenson Drive intersection.

The new SB Jansen Dr bus stop will create a station pair to the NB Jansen Dr bus stop. While it is being completed in this area, it is recommended to improve the NB Jansen Drive bus stop as part of the overall improvement project. The NB Jansen Drive bus stop (stop ID 1891) has an existing daily ridership of 29 passengers per day. It is currently a far-side stop with a bench and lacks an ADA compliant landing area.

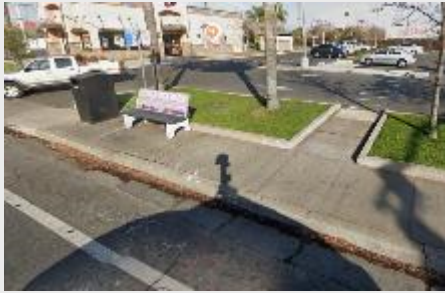
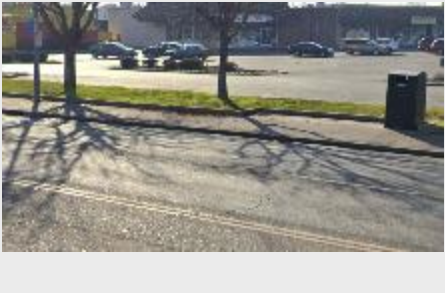
Figure A- 22 Stockton Blvd & McMahon Dr

Northbound	Southbound
Stop ID	1890	1854
Daily Ridership	Boarding: 45 Alighting: 18 Total: 63	Boarding: 21 Alighting: 41 Total: 62
Cost	Tier 1: \$189,700 Tier 2: \$291,900	Tier 1: \$158,200 Tier 2: \$245,300
Key Considerations (ADA, ROW)	<ul style="list-style-type: none"> No Landing Area Tier 1 and Tier 2: 0' ROW Required 	<ul style="list-style-type: none"> Landing Area and Curb Ramp Accessible Tier 1 and Tier 2: 0' ROW Required
Proposed Improvements	<p>Tier 1: Extend station area along back of sidewalk to accommodate shelter with bench, RTIS, system and route map, Braille signage, and pedestrian scale lighting. Upgrade 3 curb ramps at NE and SE corner of McMahon.</p> <p>Tier 2: Create shared cycle track stop and maintain all Tier 1 improvements.</p>	<p>Tier 1: Extend station area along back of sidewalk to accommodate shelter with bench, RTIS, system and route map, Braille signage, and pedestrian scale lighting.</p> <p>Tier 2: Create shared cycle track stop and maintain all Tier 1 improvements.</p>

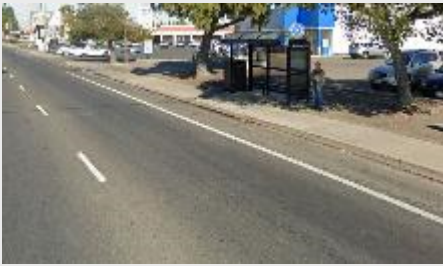
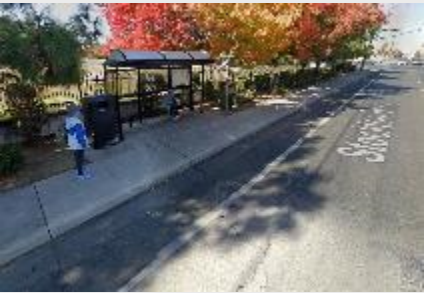
Figure A- 23 Stockton Blvd & Lemon Hill Ave

Lemon Hill Ave Northbound	Lemon Hill Ave Southbound
Stop ID	1889	1855
Daily Ridership	Boarding: 62 Alighting: 23 Total: 85	Boarding: 22 Alighting: 37 Total: 59
Cost	Tier 1: \$193,900 Tier 2: \$229,400	Tier 1: \$208,300 Tier 2: \$232,400
Key Considerations (ADA, ROW)	<ul style="list-style-type: none"> ▪ Landing Area and Curb Ramp Accessible ▪ Tier 1 and Tier 2: 0' ROW Required 	<ul style="list-style-type: none"> ▪ Landing Area and Curb Ramp Accessible ▪ Tier 1 and Tier 2: 2' ROW Required
Proposed Improvements	<p>Tier 1: Extend station area around back of sidewalk to accommodate RTIS, Braille signage, and pedestrian scale lighting. Upgrade 4 curb ramps at NE and SE corner of intersection.</p> <p>Tier 2: Create shared cycle track stop and route sidewalk behind bus stop. Add RTIS, Braille signage, and pedestrian scale lighting. Upgrade 4 curb ramps at NE and SE corner of intersection.</p>	<p>Tier 1: Widen station platform into existing landscaping area to accommodate RTIS, Braille signage, and pedestrian scale lighting. Upgrade 4 curb ramps at NW and SW corner of intersection.</p> <p>Tier 2: Create shared cycle track stop. Widen station platform to accommodate RTIS, Braille signage, and pedestrian scale lighting. Upgrade 4 curb ramps at NW and SW corner of intersection.</p>

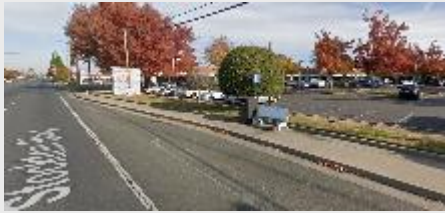
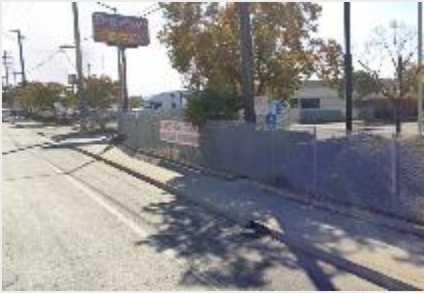
Figure A- 24 Stockton Blvd & Dias Ave

Dias Ave Northbound	Dias Ave Southbound
Stop ID	1888	1856
Daily Ridership	Boarding: 16 Alighting: 6 Total: 22	Boarding: 4 Alighting: 26 Total: 30
Cost	Tier 1: \$144,300 Tier 2: \$476,000	Tier 1: \$144,600 Tier 2: \$231,700
Key Considerations (ADA, ROW)	<ul style="list-style-type: none"> No Landing Area Tier 1 and Tier 2: 0' ROW Required 	<ul style="list-style-type: none"> No Landing Area Tier 1 and Tier 2: 4' ROW Required
Proposed Improvements	<p>Tier 1: Extend station area along back of sidewalk to accommodate accessible landing area, shelter with bench, Braille signage, and route maps.</p> <p>Tier 2: Create transit island for in-lane stop routing bike lane and sidewalk behind bus stop. Add shelter with bench, Braille signage, and route map.</p>	<p>Tier 1: Extend station area along back of sidewalk to accommodate accessible landing area, shelter with bench, Braille signage, system and route maps.</p> <p>Tier 2: Create shared cycle track stop. Add shelter with bench, Braille signage, system and route maps.</p>

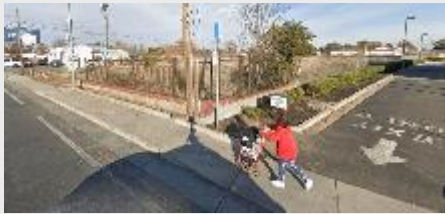
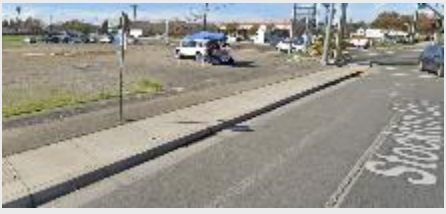
Figure A- 25 Stockton Blvd & Elder creek Rd/47th Ave

Elder creek Rd Northbound	47 th Ave Southbound
Stop ID	1887	1857
Daily Ridership	Boarding: 41 Alighting: 17 Total: 58	Boarding: 22 Alighting: 43 Total: 65
Cost	Tier 1: \$171,800 Tier 2: \$259,000	Tier 1: \$163,100 Tier 2: \$250,300
Key Considerations (ADA, ROW)	<ul style="list-style-type: none"> No Landing Area Tier 1 and Tier 2: 0' ROW Required 	<ul style="list-style-type: none"> No Landing Area Tier 1 and Tier 2: 4' ROW Required Stop is currently located south of Patterson Way, approximately 560' south of Riza Way.
Proposed Improvements	<p>Tier 1: Shift stop further north to existing light pole. Remove existing fence to allow for a widened station area at back of sidewalk to accommodate shelter with bench, RTIS, trash receptacle, system and route maps, Braille signage, and pedestrian scale lighting.</p> <p>Tier 2: Create shared cycle track stop. Shift stop further north and widen sidewalk to accommodate shelter with bench, trash receptacle, RTIS, System and Route signage, Braille signage, and pedestrian scale lighting.</p>	<p>Tier 1: Widen sidewalk into adjacent property accommodate shelter with bench, RTIS, trash receptacle, system and route maps, Braille signage, and pedestrian scale lighting.</p> <p>Tier 2: Create shared cycle track stop. Widen sidewalk into adjacent property to accommodate shelter with bench, trash receptacle, RTIS, System and Route signage, Braille signage, and pedestrian scale lighting.</p>

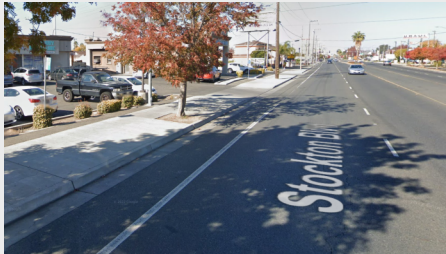
Figure A- 26 Stockton Blvd & 48th Ave

Northbound	48th Ave Southbound
Stop ID		1858
Daily Ridership		Boarding: 6 Alighting: 10 Total: 16
Cost		Tier 1: \$15,300 Tier 2: \$183,700
Key Considerations (ADA, ROW)		<ul style="list-style-type: none"> ▪ Landing Area and Curb Ramp Accessible ▪ Tier 1 and Tier 2: 0' ROW Required
Proposed Improvements		<p>Tier 1: Relocate sign to face of curb. Add shelter with bench, Braille signage, system and route maps.</p> <p>Tier 2: Create shared cycle track stop with bench, Braille signage, and route map.</p>
Image Credit: Google Maps

- 48th Ave SB (stop ID 1858) is a midblock stop with no station pair and no amenities but it is fully ADA compliant. The bus stop flag is located at the back of the sidewalk and is not easily visible from the roadway. Due to its proximity to nearby shopping plazas and restaurants, it is recommended to add a shelter with a bench to provide a more comfortable waiting environment and increase ridership. Improvements to this location include adding a shelter with a bench, Braille signage, and system and route maps, and relocating the bus stop flag to more easily identify the bus stop.

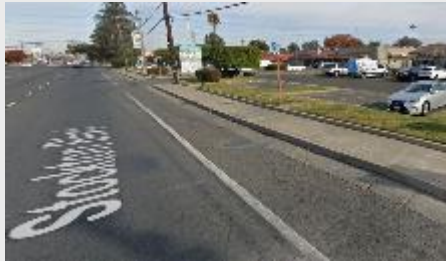
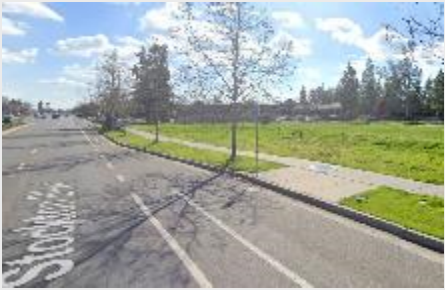
Figure A- 28 Stockton Blvd & 65th Ave

Northbound	Southbound
Stop ID	1884	1860
Daily Ridership	Boarding: 168 Alighting: 85 Total: 252	Boarding: 144 Alighting: 264 Total: 407
Cost	Tier 1: \$307,500 Tier 2: \$554,900	Tier 1: \$187,200 Tier 2: \$457,500
Key Considerations (ADA, ROW)	<ul style="list-style-type: none"> ▪ Landing Area and Curb Ramp Accessible ▪ Tier 1: 8' ROW Required ▪ Tier 2: 0' ROW Required 	<ul style="list-style-type: none"> ▪ No ADA Landing Area ▪ Tier 1 and Tier 2: 0' ROW Required
Proposed Improvements	<p>Tier 1: Extend station platform along back of sidewalk and create shared cycle track stop. Due to high daily ridership, add two shelters with benches, bench, RTIS, pedestrian scale lighting, system and route maps, and Braille signage.</p> <p>Tier 2: Create transit island routing bike lane behind bus stop. Due to high daily ridership, add two shelters with benches, bench, RTIS, pedestrian scale lighting, system and route maps and Braille signage.</p>	<p>Tier 1: Extend station platform at back of sidewalk and create shared in-lane stop. Due to high daily ridership, add two shelters with benches, bench, RTIS, pedestrian scale lighting, system and route maps, and Braille signage.</p> <p>Tier 2: Create transit island routing bike lane behind bus stop. Due to high daily ridership, add two shelters with benches, bench, RTIS, pedestrian scale lighting, system and route maps, Braille signage. Add 2 curb ramps for access to transit island.</p>

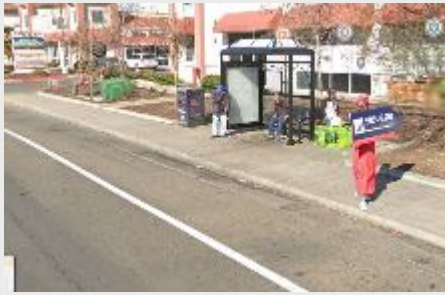
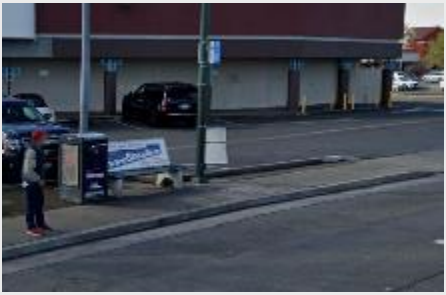
Figure A- 29 Stockton Blvd & Florin Ave NB/ Lindale Ave SB

Florin Ave Northbound	Lindale Ave Southbound
Stop ID	1861	2166
Daily Ridership	Boarding: 2 Alighting: 8 Total: 10	Boarding: 17 Alighting: 53 Total: 70
Cost	Tier 1: \$173,600 Tier 2: \$303,500	Tier 1: \$205,100 Tier 2: \$291,500
Key Considerations (ADA, ROW)	<ul style="list-style-type: none"> No ADA Landing Area Tier 1 and Tier 2: 0' ROW Required 	<ul style="list-style-type: none"> No ADA Landing Area Tier 1 and Tier 2: 4.5' ROW Required
Proposed Improvements	<p>Tier 1: Extend station area along back of sidewalk to accommodate landing area, shelter with bench, trash receptacle, Braille signage, system and route maps.</p> <p>Tier 2: Create shared in-lane cycle track stop. Extend station area along back of sidewalk to accommodate landing area, shelter with bench, trash receptacle, Braille signage, system and route maps. Upgrade 3 curb ramps on NW and SW corner of Florin Rd and Stockton Blvd intersection.</p>	<p>Tier 1: Extend station area along back of sidewalk to accommodate accessible landing area. Add shelter with bench, RTIS, trash receptacle, Braille signage, system and route map and pedestrian scale lighting.</p> <p>Tier 2: Create shared in-lane cycle track stop. Extend station area along back of sidewalk to accommodate accessible landing area. Add shelter with bench, RTIS, trash receptacle, Braille signage, system and route map and pedestrian scale lighting.</p>
