**Sacramento Regional Transit
District**

Stockton Boulevard Implementation Plan

July 2023

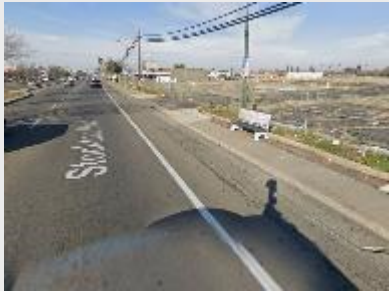
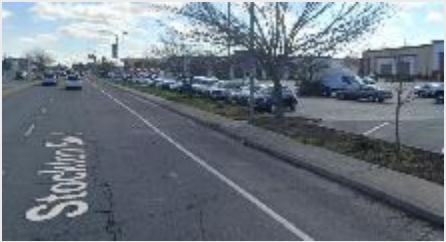
Figure A- 30 Stockton Blvd & Gerber Rd SB/ Suncountry Ln NB

Suncountry Ln Northbound	Gerber Rd Southbound
Stop ID	2376	2408
Daily Ridership	Boarding: 5 Alighting: 5 Total: 10	Boarding: 8 Alighting: 4 Total: 12
Cost	Tier 1: \$659,400 Tier 2: \$798,500	Tier 1: \$837,300 Tier 2: \$946,400
Key Considerations (ADA, ROW)	<ul style="list-style-type: none"> No Landing Area Tier 1 and Tier 2: 0' ROW Required 	<ul style="list-style-type: none"> No Landing Area Tier 1 and Tier 2: 0' ROW Required
Proposed Improvements	<p>Must: Add/widen sidewalk in missing section between Gerber Rd and NB Suncountry Ln bus stop. Upgrade 2 existing curb ramps on NE and SE corners of Gerber Rd and Stockton Blvd.</p> <p>Tier 1: Add Braille signage. No additional changes to existing bus stop</p> <p>Tier 2: Create shared cycle track stop. Add Braille signage and crossing on north leg of Massie Ct with two new curb ramps.</p>	<p>Must: Add/widen sidewalk in missing section between Gerber Rd and SB Gerber Rd bus stop. Upgrade 1 existing curb ramp on NW corner of Gerber Rd and Stockton Blvd intersection and add 1 curb ramp to SW corner of intersection.</p> <p>Tier 1: Relocate existing stop to near-side of Whispering Palms Ln. Close or relocate existing driveway to accommodate station platform with accessible landing area, bench, Braille signage, system and route maps. At Gerber Rd intersection, upgrade 3 existing curb ramps and add new curb ramp on SW corner of intersection.</p> <p>Tier 2: Create a shared cycle track stop. Relocate existing stop to near-side of Whispering Palms Ln. Close or relocate existing driveway to accommodate station platform with accessible landing area, bench, Braille signage, system and route maps. At Gerber Rd intersection, upgrade 3 existing curb ramps and add new curb ramp on SW corner of intersection.</p>

Gerber Rd SB, Suncountry Ln NB, and Massie Ct 1 SB (stop ID 2408, 2376, and 2409 respectively) are located near residential areas with some shopping plazas nearby. They all have relatively low ridership at 10, 12, and 8 daily riders, respectively. Between Gerber Rd and Suncountry Ln, roughly 400' of sidewalk is missing on the east side of Stockton Blvd and

roughly 450' of sidewalk is missing on the west side of Stockton Blvd. The Gerber Rd SB and Massie Ct 1 SB bus stops are both missing accessible landing areas and have no existing amenities. Suncountry Ln NB currently has a shelter with a bench and a tight accessible landing area.

This location received priority designation largely due to the lack of ADA accessibility in the area, from missing sections of sidewalk, curb ramps that require upgrading, and missing accessible landing areas from the two SB stops. Additionally, all improvements can be completed within the existing ROW. The anticipated cost for the Tier 1 improvements is \$1,623,800; \$659,400 for the NB stop, \$837,300 for the SB Gerber Rd stop, and \$127,100 for the SB Massie Ct 1 stop. The anticipated cost for the Tier 2 improvements is \$1,981,600; \$798,500 for the NB stop, \$946,400 for the SB Gerber Rd stop, and \$236,700 for the SB Massie Ct 1 stop.

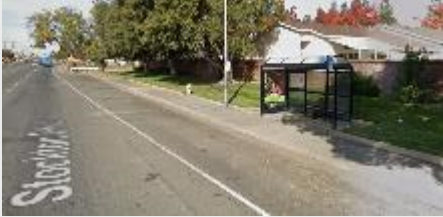
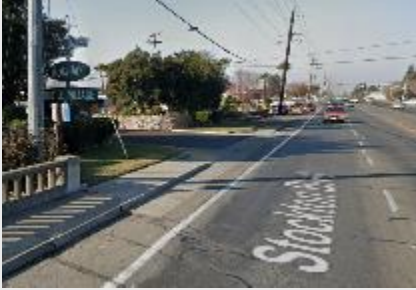
Figure A- 31 Stockton Blvd & Massie Ct 1 (SB)

Northbound	Massie Ct 1 Southbound
Stop ID		2409
Daily Ridership		Boarding: 2 Alighting: 6 Total: 8
Cost		Tier 1: \$127,100 Tier 2: \$236,700
Key Considerations (ADA, ROW)		<ul style="list-style-type: none"> ▪ No Landing Area ▪ Tier 1 and Tier 2: 0' ROW Required
Proposed Improvements		<p>Tier 1: Extend station area at back of sidewalk to accommodate accessible landing area, bench, Braille signage, system and route maps.</p> <p>Tier 2: Create a shared cycle track stop with and extend station area at back of sidewalk at bus stop to accommodate accessible landing area, bench, Braille signage, system and route maps.</p>
Image Credit: Google Maps
